Re: Notice of Violation
Gatto Industrial Platers, Inc.
EPA ID No.: ILD 984 832 311

COMPLIANCE EVALUATION INSPECTION REPORT

INSTALLATION NAME: Gatto Industrial Platers, Inc.
U.S. EPA ID No.: ILD 984 832 311
LOCATION ADDRESS: 4620 West Roosevelt Road
Chicago, IL 60644
NAICS CODES: 332813 (Electroplating, Plating, Polishing,
Anodizing and Coloring)
DATE OF INSPECTION: May 31, 2013
EPA INSPECTOR: Michael Valentino

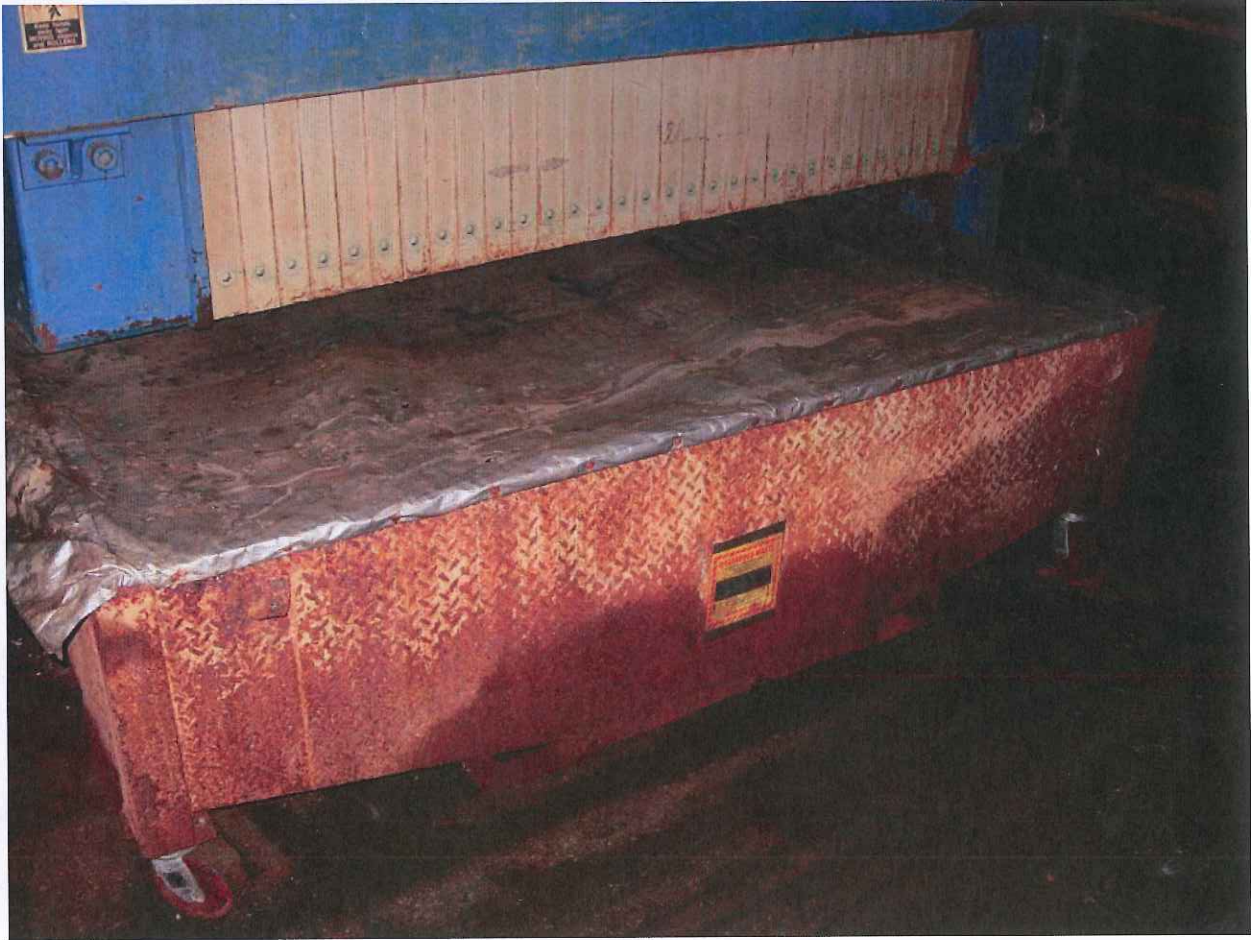
PHOTO 1

We began the site tour in the wastewater treatment area. (Photos 1-4) I observed a plate-and-frame filter press and beneath it was a container – closed and properly labeled – holding filter press sludge (F006). (Photo 1)

PHOTO No.	DATE	TIME	PHOTOGRAPHER	DESCRIPTION
1	5/31/13	11:35 am	M. Valentino	Plate and frame filter press and wastewater treatment sludge (F006) container. Container is labeled and covered. Plating sludge is transferred from containers such as this one to a roll-off box (see Photo 11).
2	5/31/13	11:37 am	M. Valentino	Cyanide destruction tank. Sodium hypochlorite is metered in to chlorinate hydrogen cyanide to form carbon dioxide and nitrogen.
3	5/31/13	11:42 am	M. Valentino	Waste treatment area. Two more plate and frame filter presses along with six F006 containers (two of which are not shown in this photo). The filter press to the right of the photo was the one in most recent use at the time of the photo. The container beneath it was filled to capacity. Two of the six F006 containers observed in this room were not affixed with hazardous waste labels, while four were. Gatto personnel corrected this at the time of the inspection by affixing hazardous waste labels to the two unmarked containers. These containers are interpreted to be satellite accumulation containers because F006 sludge is generated as it is pressed in the filter press and deposited into these containers. The containers are then transferred to the roll-off box area and the contents are deposited into the roll-off for off-site transport to Envirite. The container to the right of the photo, beneath the filter press, was interpreted by the inspector to have been filled to capacity and that no more addition of sludge was taking place at the time it was observed to be uncovered. The container in the center background of the photo was more than 3/4 th filled with sludge and was also uncovered at the time the photo was taken.

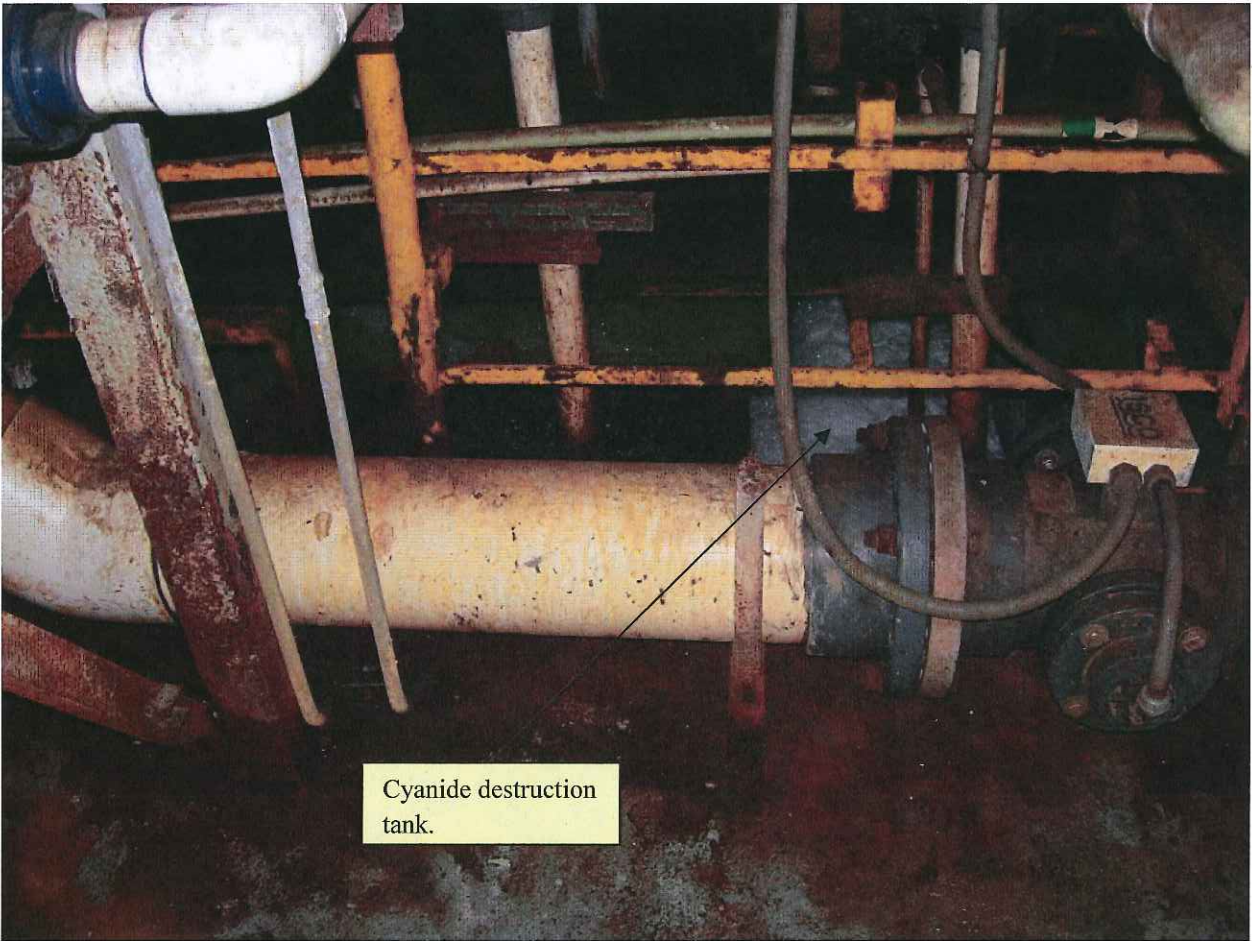
PHOTO 2

I also observed an open-top below ground tank in which process waters from the facility's plating lines are treated with sodium hypochlorite (NaClO) to oxidize cyanide in the plating solution. (Photo 2)

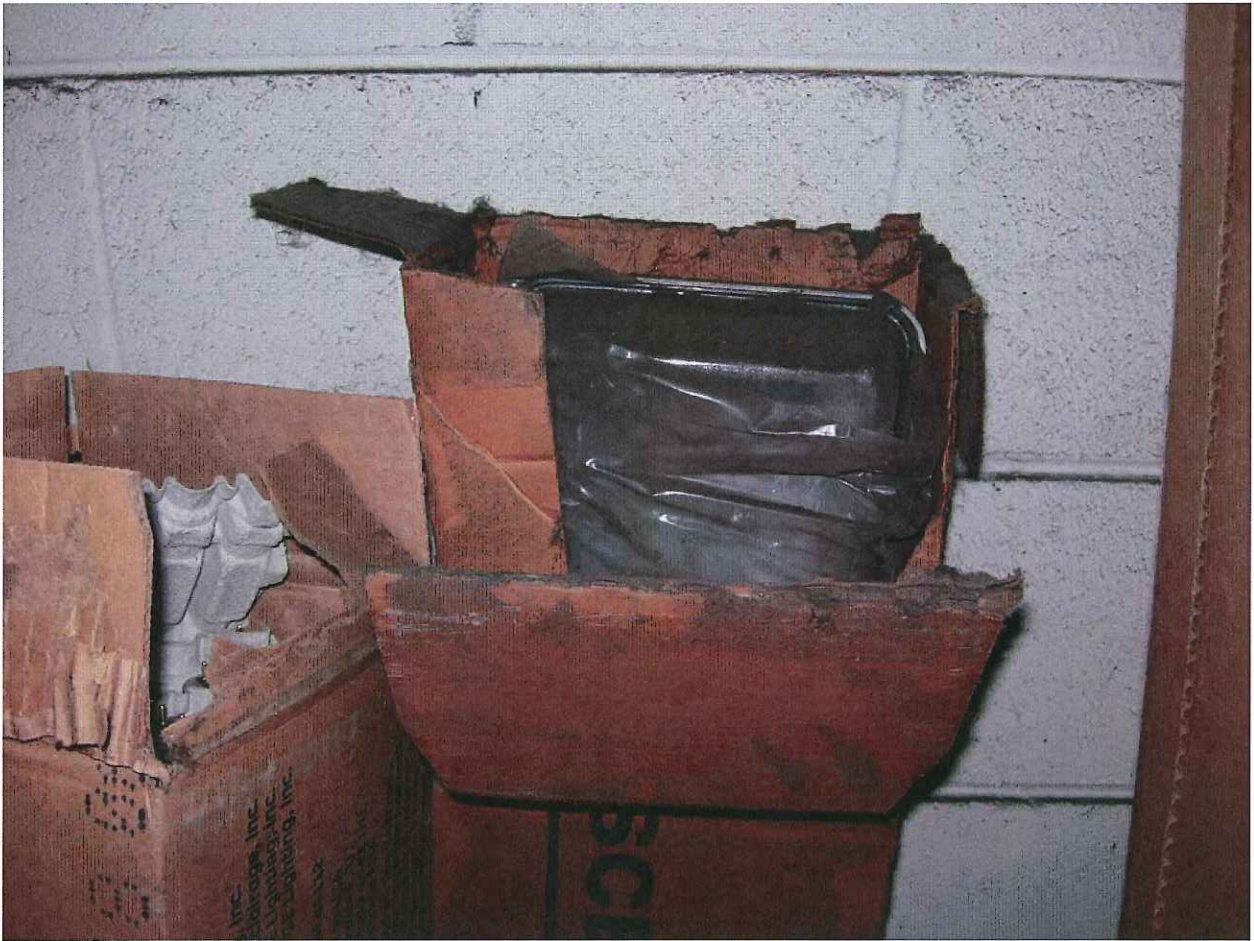
PHOTO 10

PHOTO No.	DATE	TIME	PHOTOGRAPHER	DESCRIPTION
10	5/31/13	11:58 am	M. Valentino	Used fluorescent light bulb storage area. There is a mix of used and new lamps in this area. Boxes containing used lamps are not securely closed nor labeled.
11	5/31/13	12:01 pm	M. Valentino	Roll-off (20 cu yd) of wastewater treatment sludge (F006) awaiting shipment. The container is covered, secured and properly labeled. There was no evidence of spillage around the roll-off.

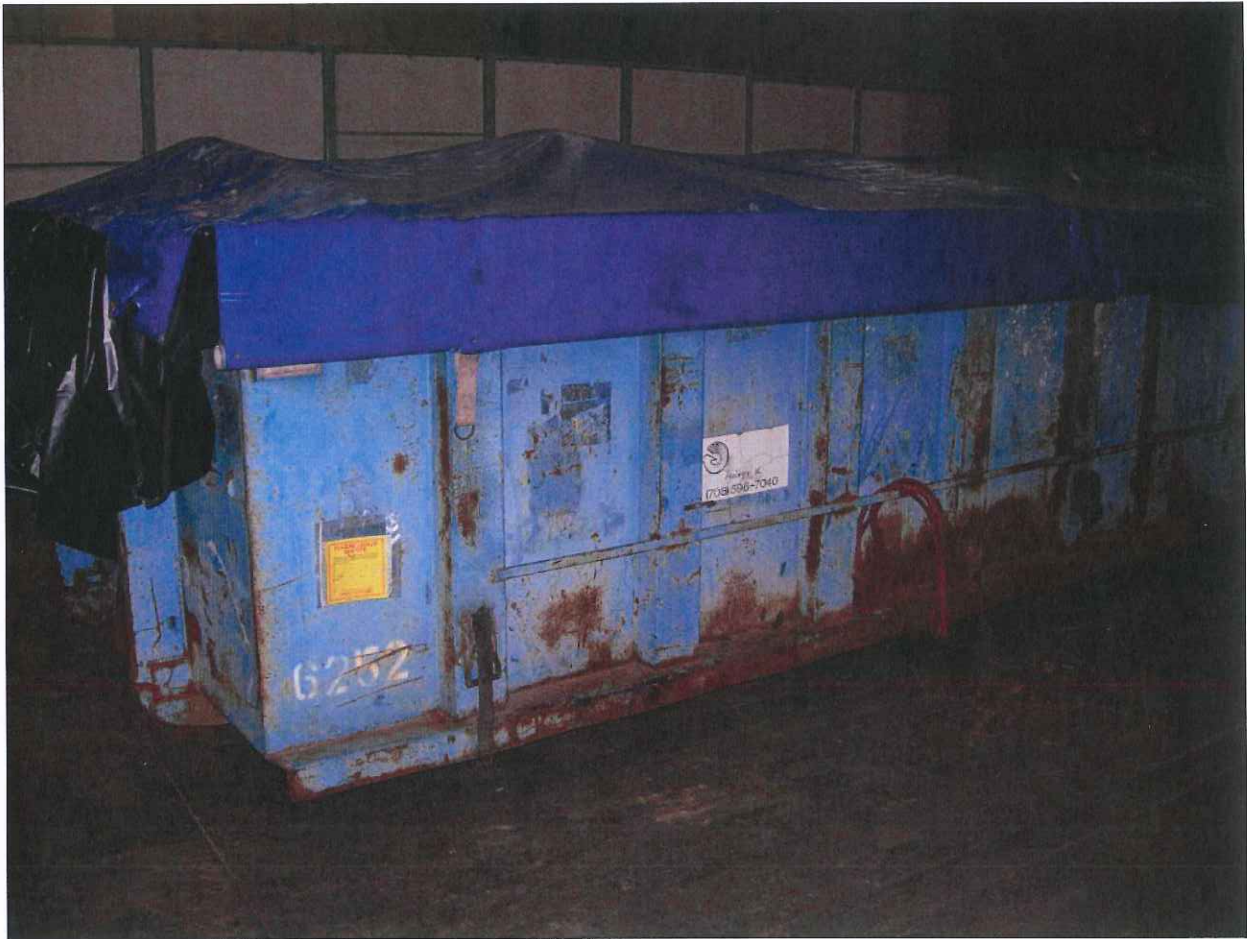
PHOTO 11

We concluded the inspection by observing a roll-off box (20 cubic yard container⁸) which was awaiting shipment. (Photo 11) The roll-off contained wastewater treatment sludge (F006). The roll-off was lined with a plastic liner and it was closed with a securely fastened tarp over it. A hazardous waste label was filled out and attached to the roll-off inside of a clear plastic sleeve. Envirite's phone number was also clearly marked on the side of the roll-off. I did not observe any spillage on the ground around or near the roll-off. I observed that the condition of the floor was generally good with no cracks or gaps. There was no evidence of spillage of filter press sludge on the ground in this area. The roll-off had some surface rust but appeared to be in good condition and properly managed.
